Performance of Concrete Bridge Decks of Similar Construction and Environment, but Different Traffic Loads

Transportation Research Record: Journal of the Transportation Research Board, No. 2550, Transportation Research Board, Washington, D.C., 2016, pp. 22–30. DOI: 10.3141/2550-04

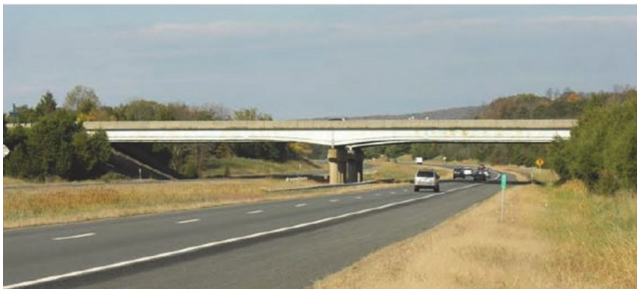
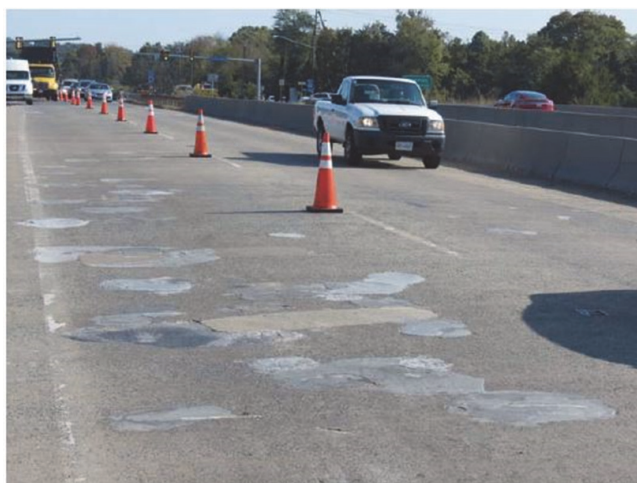
northbound bridge (structure number 14180) are 276 ft (84.1 m) long and 42 ft (12.8 m) wide, and were built in 1979. Each bridge is a two-span, six-girder, steel built-up superstructure (Figure 1a) with a bare, cast-in-place 8 in. (200 mm) thick reinforced concrete deck constructed with removable forms. The southbound and northbound bridges carry two lanes of traffic. Traffic counts suggest a 38/62 directional split northbound/southbound, based on a 24 h turning movement count at the I-66 westbound off-ramp intersection. It stands to reason that traffic is heading southbound to eastbound in the mornings and westbound to northbound in the afternoons, and the afternoon traffic would not be traveling over the northbound bridge. In other words, a majority of the traffic comes from the north on U.S. Route 15, crosses the southbound bridge, and turns left onto eastbound I-66 in the morning. In the evening, that returning traffic would approach the interchange on westbound I-66, take the exit ramp, and turn right onto northbound U.S. Route 15 and never cross the northbound bridge.

FIGURE 1 Study bridges on U.S. Route 15 in Haymarket, Virginia: (a) side view of the northbound bridge and (b) deck surface of the southbound bridge.

the current conditions of the northbound and southbound bridges was compared through multiple NDE condition maps. All the NDE measurements were made on a 2 by 2 ft (0.6 by 0.6 m) grid, except for the GPR surveys, which were conducted in the longitudinal direction of the bridge with survey lines 2 ft (0.6 m) apart. It took two 5 h (total 10 h) lane closures to survey the bridges. In other words, considering that the surveyed deck area of each bridge was about 11,000 ft² (1,020 m²), the surveys were conducted at production rates of about 1,100 ft² (102 m²) per hour. A section of the deck surface of the southbound bridge with clearly visible patches and spalling is shown in Figure 1b.

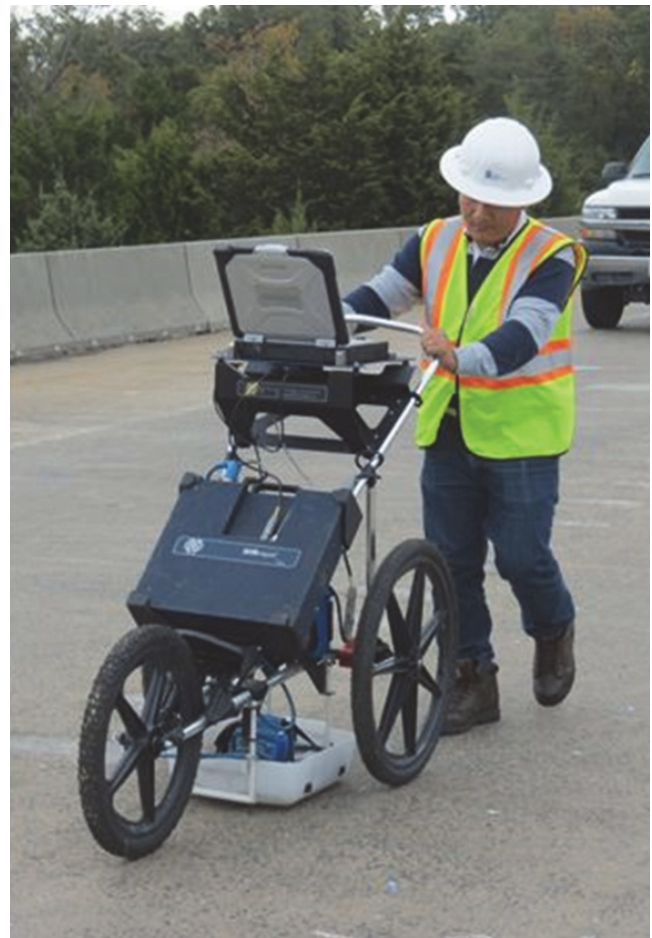
A GPR survey can be used for a qualitative assessment of the deck condition by measuring the attenuation of electromagnetic waves on the top rebar level (4). The amplitude of the reflection will be highest when the deck is in a good condition. The presence of moisture, chloride ions, iron oxide, cracks, and air-filled delaminations alters the dielectric properties and increases the attenuation of the electromagnetic waves. Thus, zones of highly-attenuated signal in GPR attenuation maps indicate locations of likely concrete deterioration, delamination, or corrosive environment. A GPR survey that was conducted with a 1.5 GHz ground coupled antenna is shown in Figure 4.

FIGURE 4 GPR survey using a 1.5 GHz ground coupled antenna.

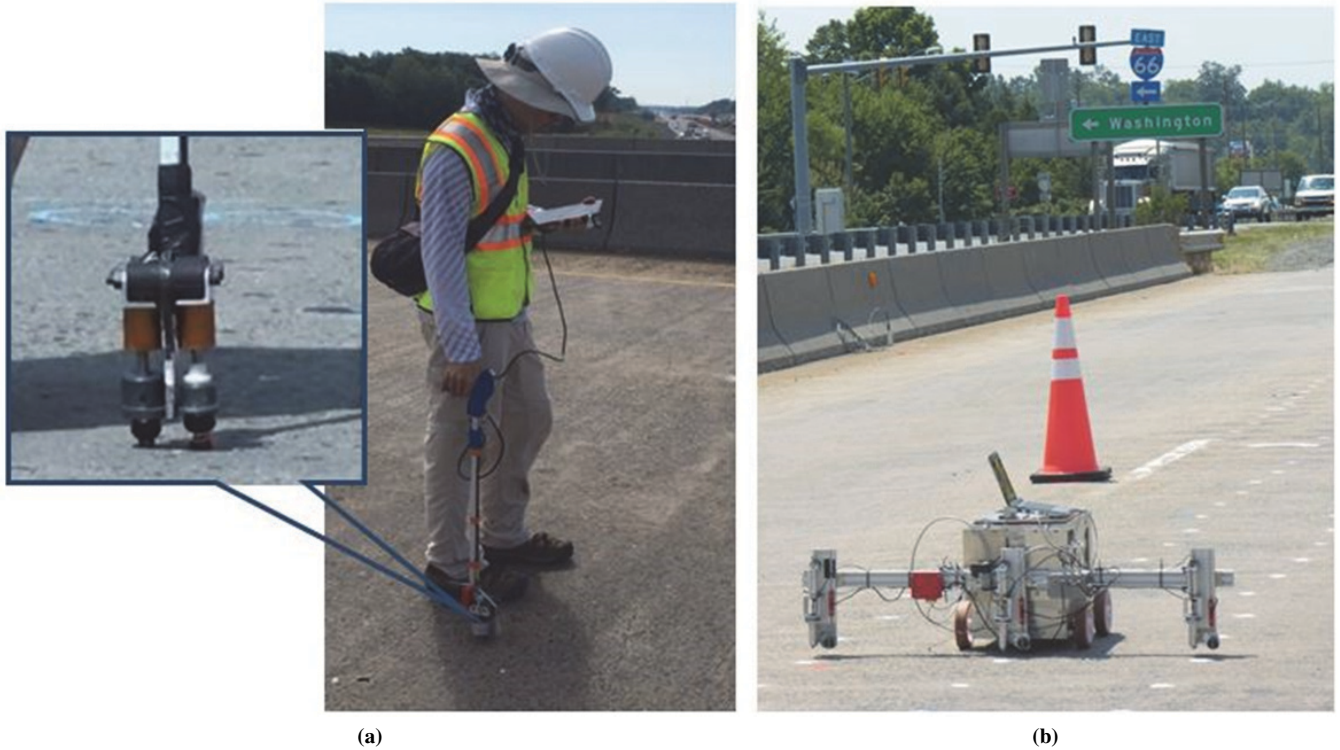
Concrete delamination is most often a result of rebar corrosion, although other types of concrete deterioration or repeated overloading, or a combination of those, can also lead to delamination. IE has been successfully implemented in detecting and characterizing delamination in bridge decks (5). IE measurements can be made with a single IE probe, consisting of an impactor and a nearby receiver (Figure 6*a*) or with multiple IE probes (Figure 6*b*), each consisting of an impactor and a sensor.

FIGURE 6 Two types of IE testing systems: (a) an IE cane and (b) a stepper.

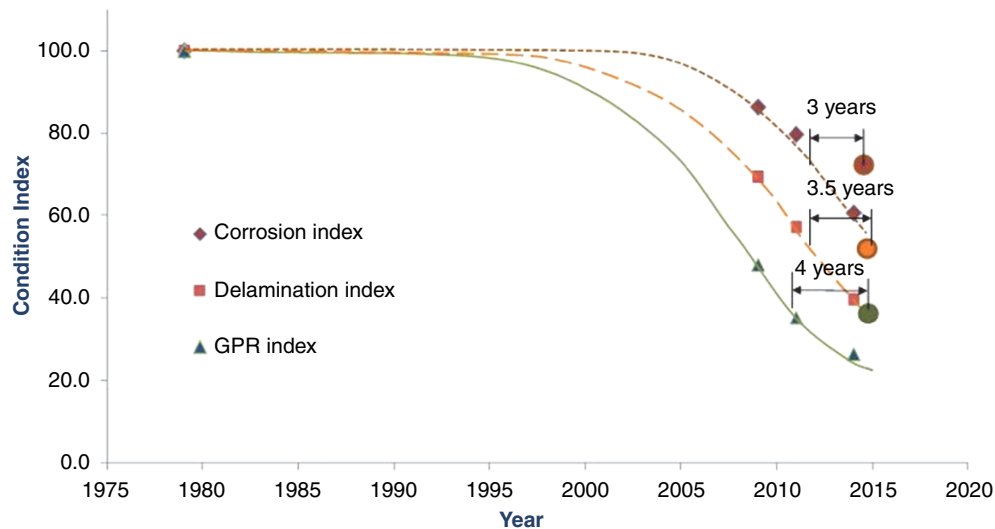
Comparison of the 2015 quantitative results for the northbound and southbound bridges shows greater deterioration of the deck of the southbound bridge. Considering that the two bridges are of the same age, design, and construction practices, and are exposed to equal environmental conditions but different traffic loads, the first cause of the better condition of the northbound deck seems to be traffic counts. The other potential cause of the better condition of the northbound bridge deck might be better initial concrete quality of the northbound deck at the time of construction. Figure 10 presents the conditions of the two bridge decks over time. The deterioration curves for corrosion, delamination, and GPR-based condition assessment are plotted for the southbound bridge based on the results of

surveys in 2009, 2011, and 2015. The same three condition assessment numbers for the northbound bridge for 2015 are marked by circles. As marked in the figure, the deterioration condition assessment numbers for the northbound bridge are only 3 to 4 years distant from the comparable condition assessment numbers for the southbound bridge. This finding can be interpreted as indicating that, assuming similar deterioration patterns for the two bridges, the remaining life of the northbound bridge is expected to be 3 to 4 years longer than that of the southbound bridge. The finding also means that the life spans of the two decks differ by approximately 10%.

FIGURE 10 Deterioration curves for the southbound deck and condition assessment number for the northbound deck.
